Central Home Solutions, LLC

Inspector: Kal Cotter

Property address: **123 west rd.**

Property Inspection Report

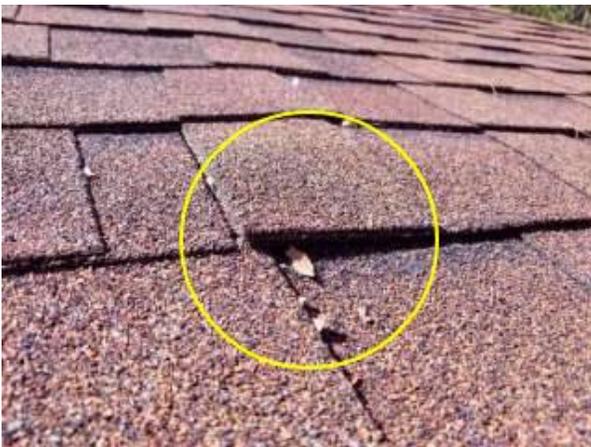
Photo 1-1
small hump in roof

A small section of sheathing was popped up. Leaks can occur as a result. This is a conducive condition for wood-destroying organisms. Recommend that a qualified contractor repair as necessary. For example, by refastening this section.

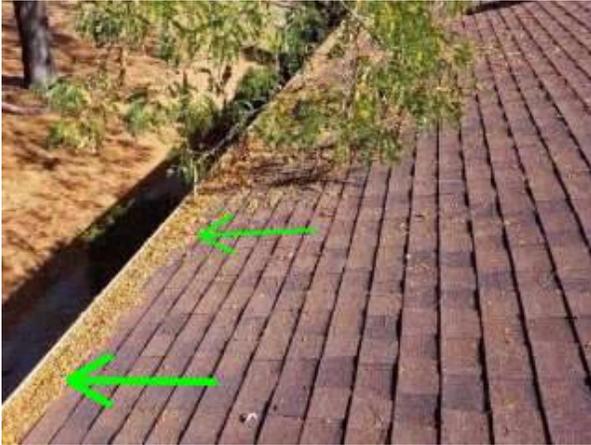
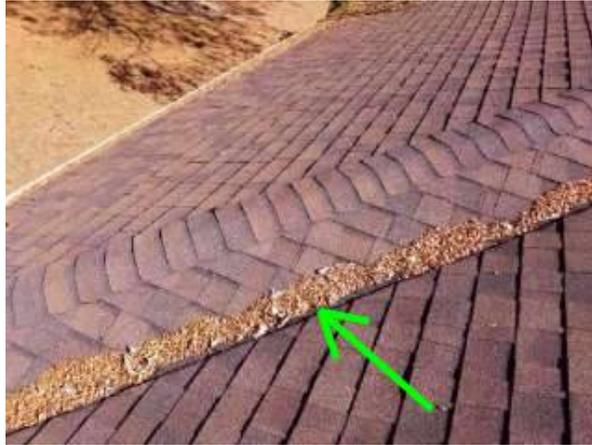
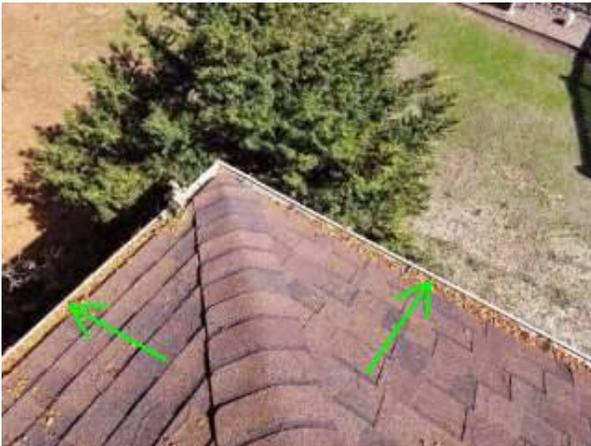
Significant amounts of debris have accumulated in one or more gutters or downspouts. Gutters can overflow and cause water to come in contact with the building exterior, or water can accumulate around the foundation. This is a conducive condition for wood-destroying organisms. Recommend cleaning gutters and downspouts now and as necessary in the future.

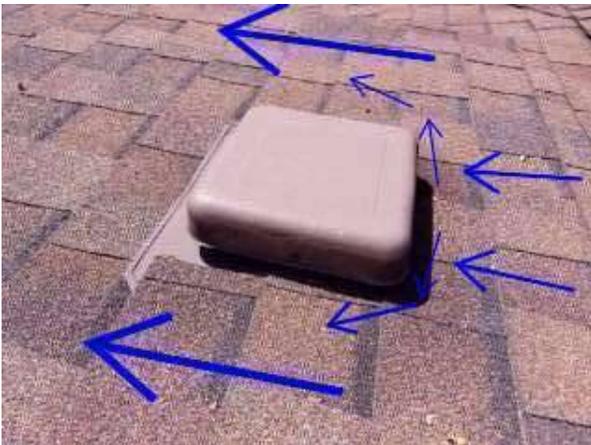
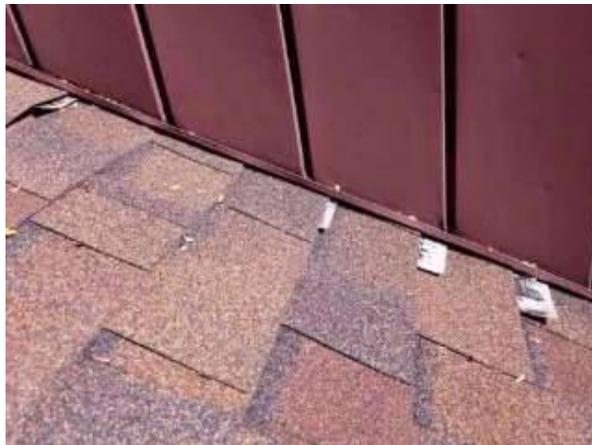
Flashings all appeared to be installed correctly and in good working condition. Some step flashing is showing. Should not be an issue. Would probably maintain at least once a year to keep an eye on it.

Photo is deceiving, water flows direction of arrows. Flashing is good.

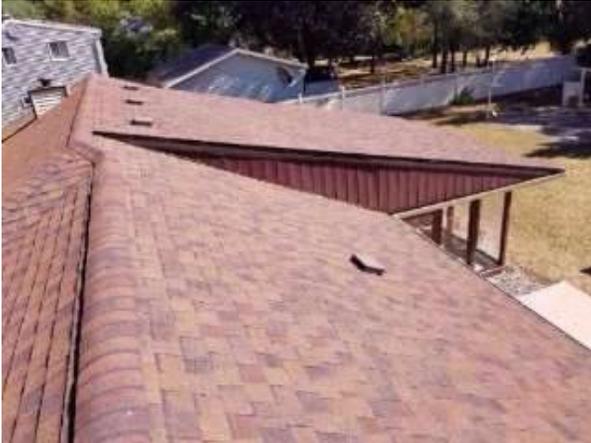
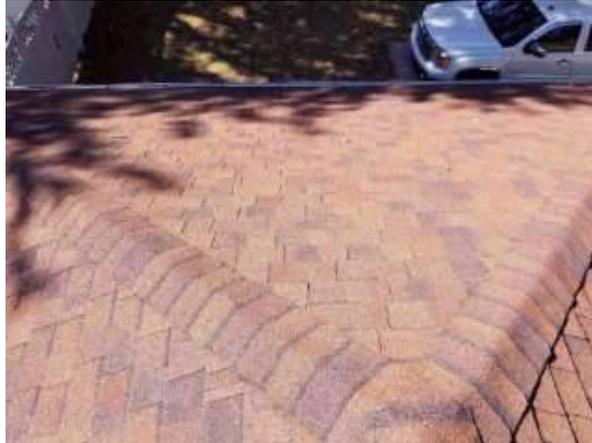
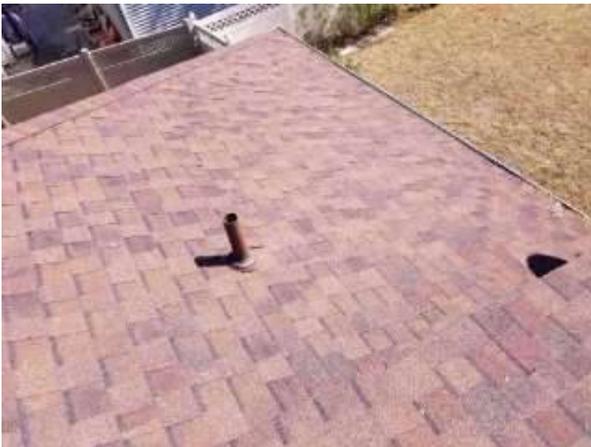
- 4) ✓ Roof appears to be in decent shape. The exact age is undetermined. I would guess between 10 and 15 years. Ask seller about exact age and warranties.

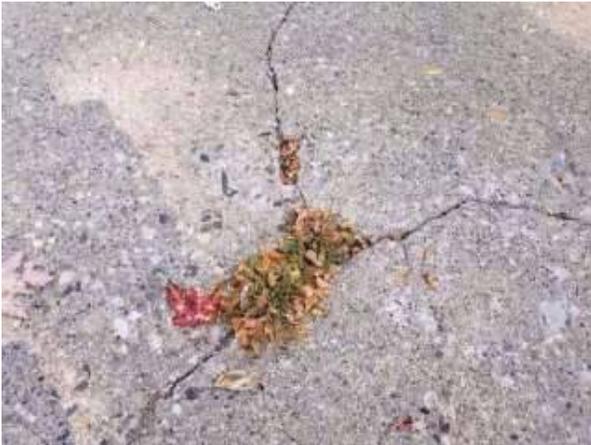
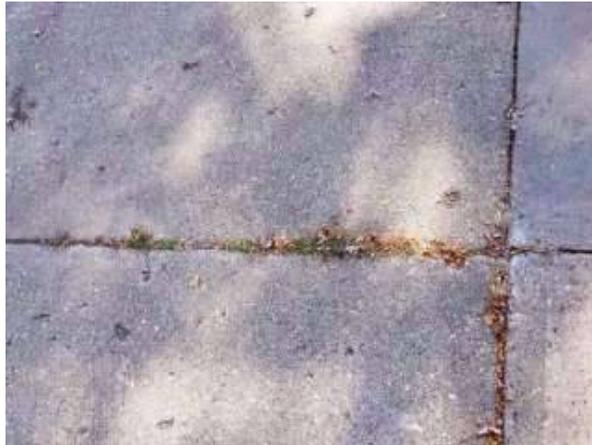
The driveway had significant growth of moss or vegetation. Recommend cleaning or removing growth to prevent deterioration. Not a major deal I would just monitor it - you don't want a lot of vegetation growing in every crack.

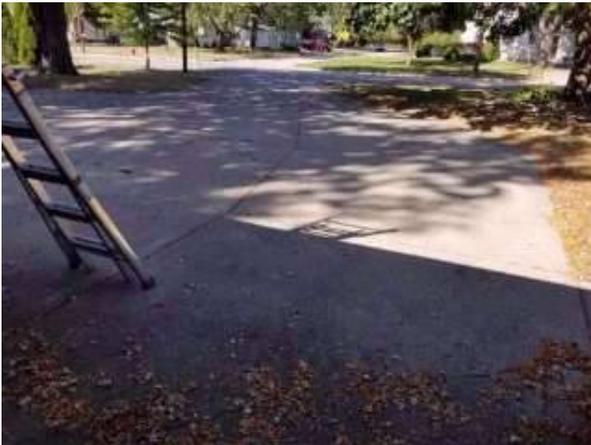
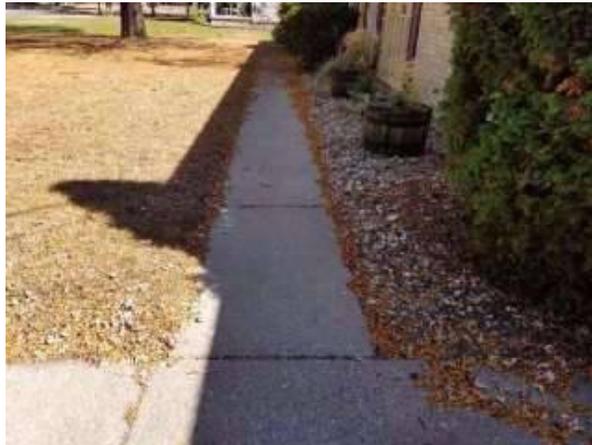
6) Sidewalk and driveway look good.

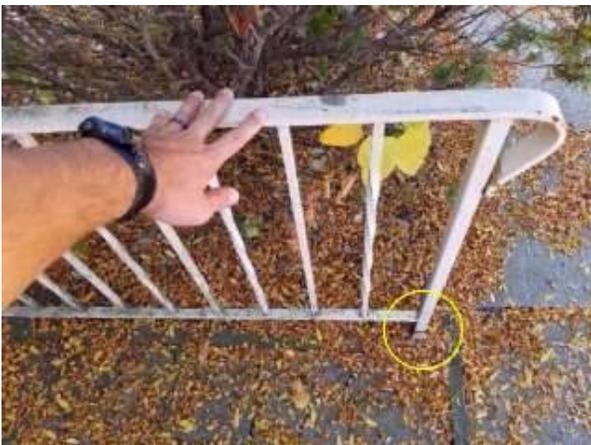
Photo 7-1

Condition of stairs, handrails and guardrails: Appeared serviceable, The right hand rail at the front porch as a little wobbly. Not a major deal. Make sure to monitor for further maintenance needs.

Handrail a little wobbly. Not a major issue. May be able to DIY it and tighten the bolts at the base.

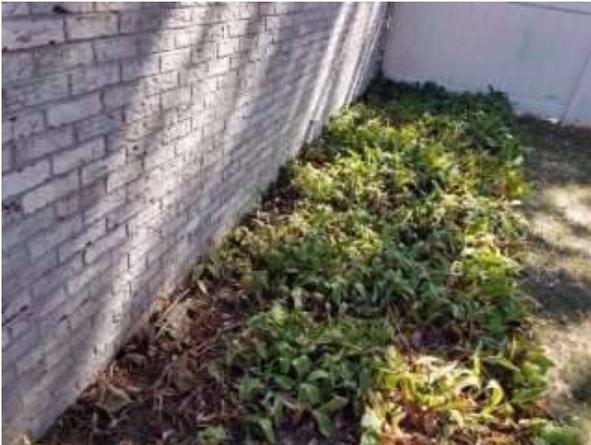
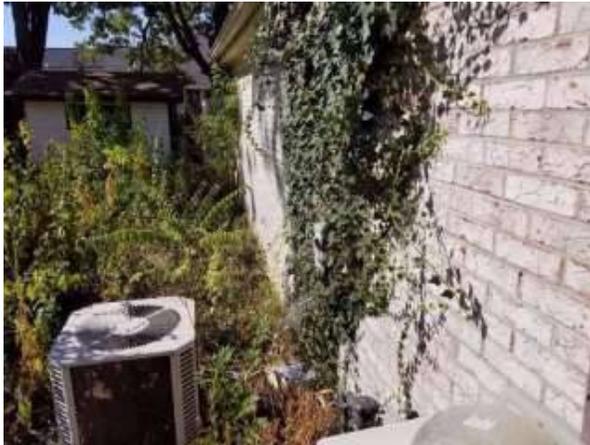
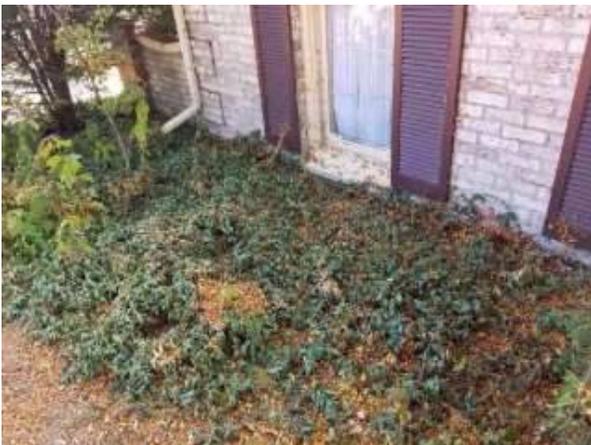
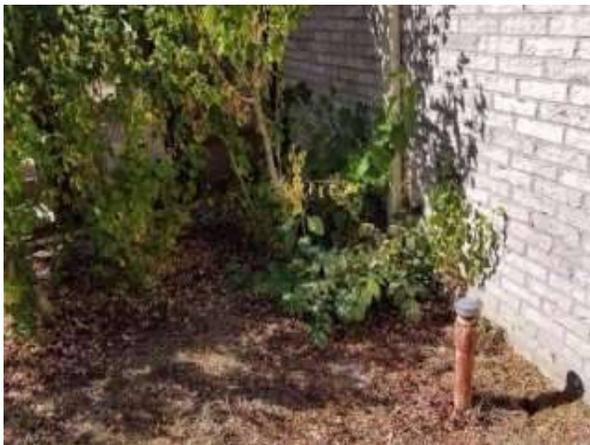
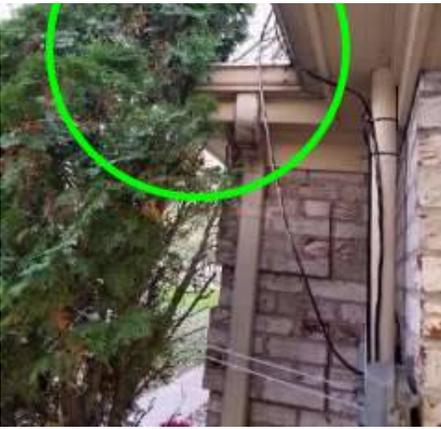
Vegetation such as trees, shrubs and/or vines was in contact with or close to the building exterior. Vegetation can serve as a pathway for wood-destroying insects and can retain moisture against the exterior after it rains. This is a conducive condition for wood-destroying organisms. Recommend pruning, moving or removing vegetation as necessary to maintain at least 6 inches of space between it and the building exterior. A 1-foot clearance is better.

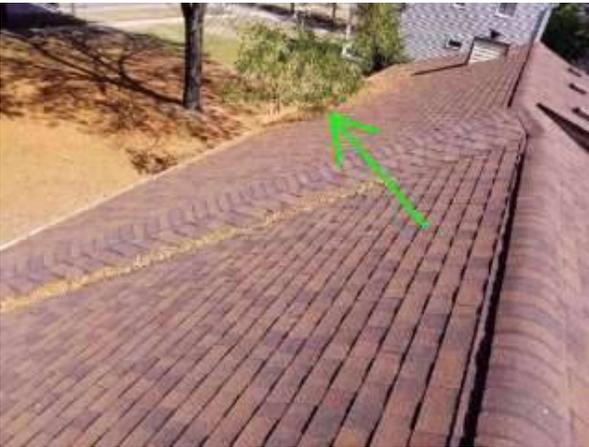
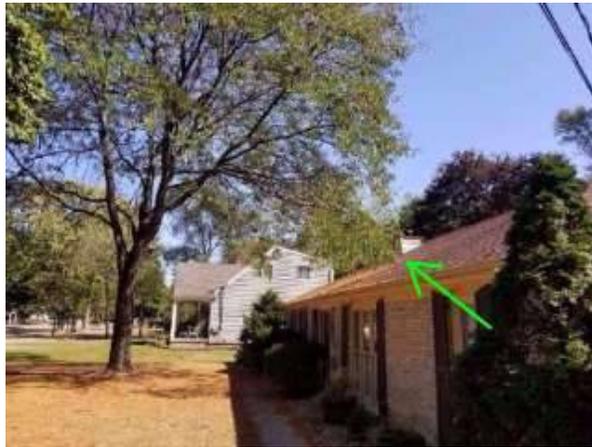
Trees were in contact with or were close to the building at one or more locations. Damage to the building can occur, especially during high winds, or may have already occurred (see other comments in this report). Recommend that a qualified tree service contractor or certified arborist remove trees as necessary to prevent damage to the building exterior.

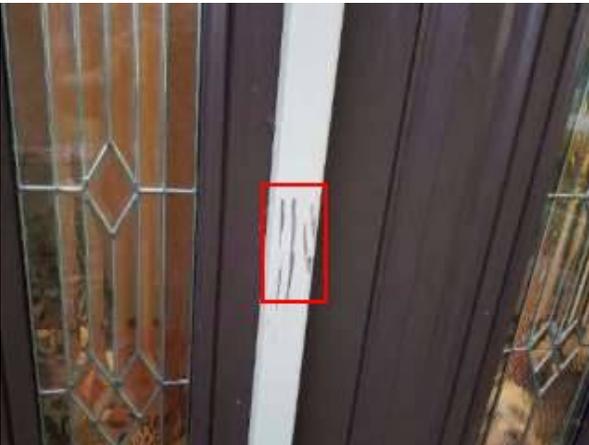
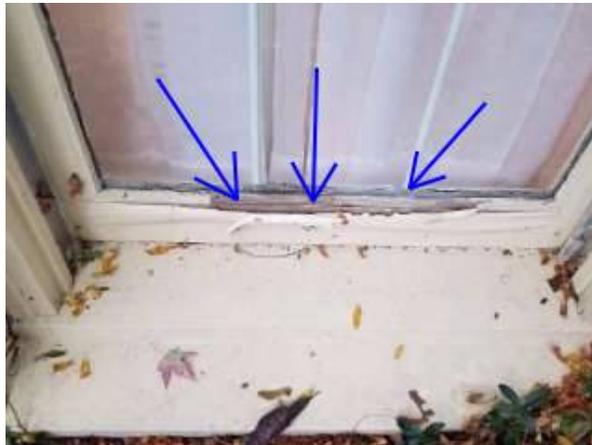
The paint or stain finish in some areas was failing (e.g. peeling, faded, worn, thinning). Siding and trim with a failing finish can be damaged by moisture. Recommend that a qualified contractor prep (e.g. clean, scrape, sand, prime, caulk) and repaint or restain the building exterior where necessary and per standard building practices. Any repairs needed to the siding or trim should be made prior to this.

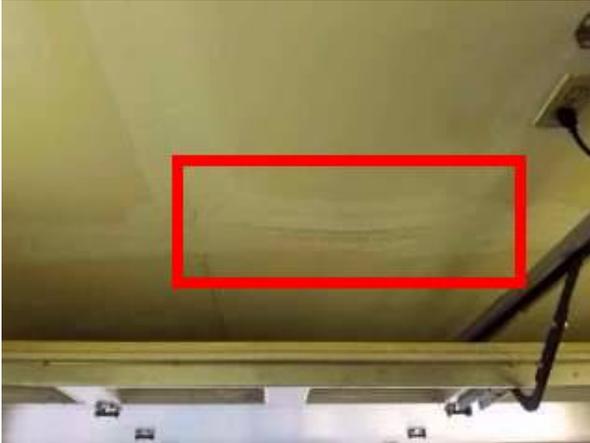
Photo 12-1

12) ✓ Garage is in good condition walls are dry walled with mud a couple spots need repair before finishing not a huge deal I would just monitor there was a lot of obstacles due to the family currently living here and in the process of moving out.

Drywall in garage ceiling is cracking. Not a major issue - I would monitor it and address it when/if finishing the garage.

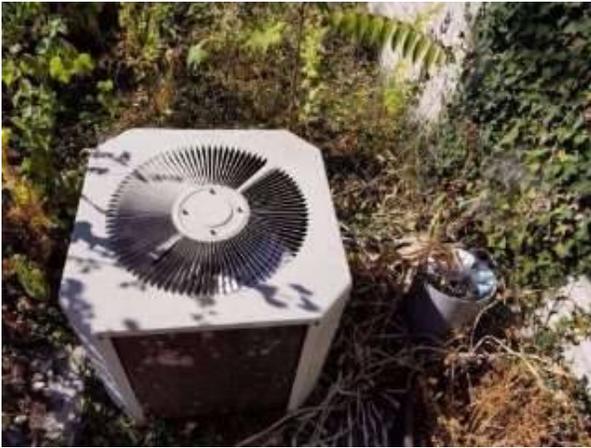
Photo 13-1

Vegetation such as trees, shrubs and/or vines were too close to the heat pump or air conditioning condensing unit. There should be at least 12 inches of clearance on all sides and at least 4-6 feet above. Inadequate clearance around and above can result in reduced efficiency, increased energy costs and/or damage to equipment. Recommend pruning and/or removing vegetation as necessary.

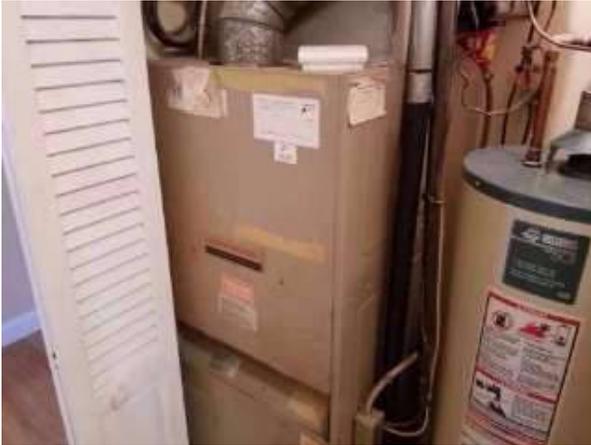
Photo 14-1

Furnace is functional. Looks close to the end of its serviceable life. Suggest monitoring for maintenance.

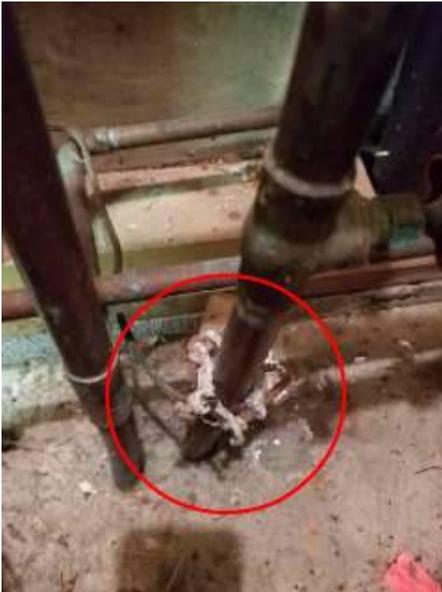
Photo 15-1

Electric grounding clamp installed on copper water supply pipe is falling apart. I would recommend that a qualified person replace clamp.

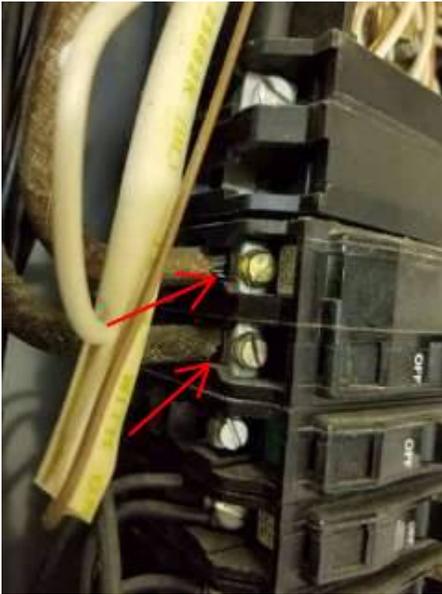
Photo 19-1

One or more branch circuits with solid-strand aluminum wires were found. Problems due to expansion and contraction with this type of wiring can cause overheating at connections between the wire and devices such as switches and receptacles, or at splices. This is a potential fire hazard. The Consumer Products Safety Commission recommends either discontinuing use of circuits with aluminum wiring, removing the wiring, or that an electrician determine if copper wire can be pig-tailed onto the ends of the aluminum wire. A qualified electrician should evaluate the full electrical system and repair as necessary. For more information, visit:

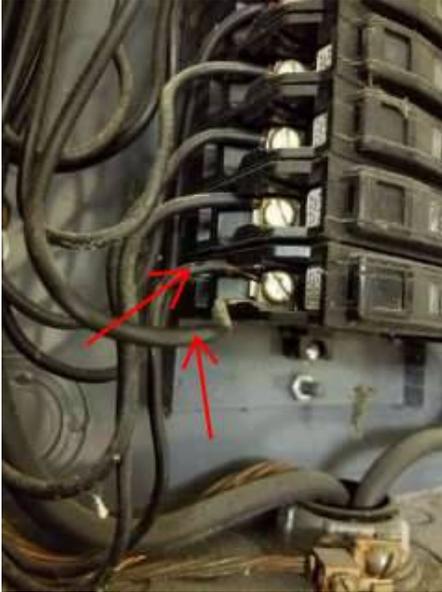
Photo 21-1

One or more circuit breakers in panel(s) #A were "double tapped," where two or more wires were installed in the breaker's lug. Most breakers are designed for only one wire to be connected. This is a safety hazard since the lug bolt can tighten securely against one wire but leave other(s) loose. Arcing, sparks and fires can result. Recommend that a qualified electrician repair as necessary. For more information, visit:

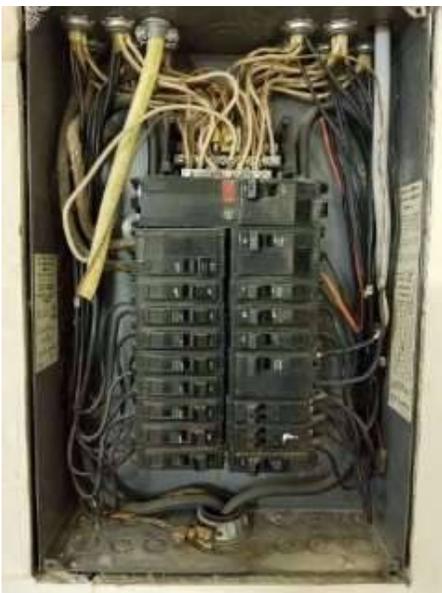
Photo 22-1

Neutral wires were doubled or bundled together under the same lug on the neutral bus bar in panel(s) #A. This is a potential safety hazard in the event that one of the circuits needs to be isolated during servicing. For one neutral to be disconnected, other neutrals from energized circuits sharing the same lug will be loosened. Power surges may result on the energized circuits and result in damage or fire. Also, multiple wires under the same lug may not be secure, resulting in loose wires, arcing, sparks and fire. Recommend that a qualified electrician repair per standard building practices. For more information, visit:

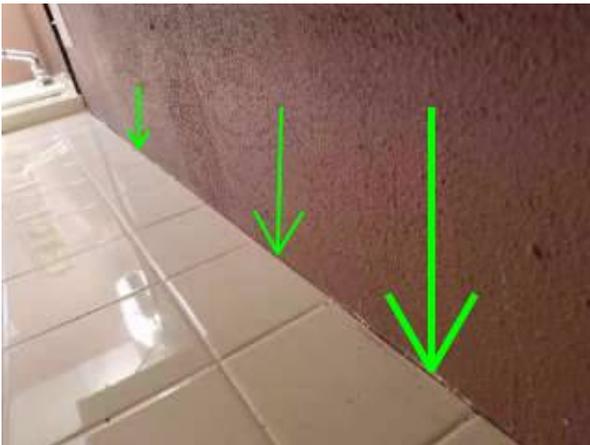
Photo 26-1

Countertops and/or backsplashes at location(s) #C were damaged or deteriorated. Recommend repairing or replacing as necessary.

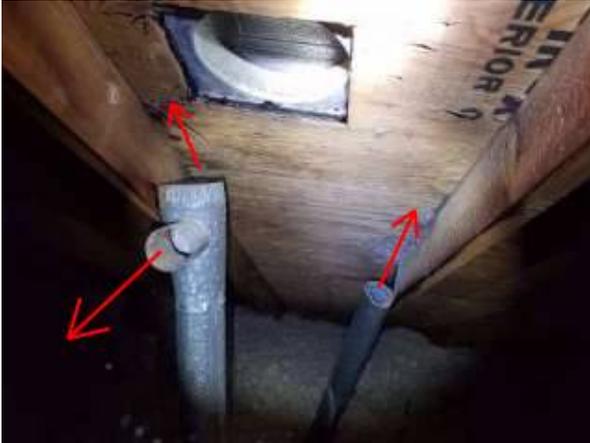
Photo 27-1

The exhaust fan at location(s) #A and B was venting into attic. Moisture may accumulate and result in mold, bacteria or fungal growth. Recommend that a qualified person clean, repair or replace fans as necessary.

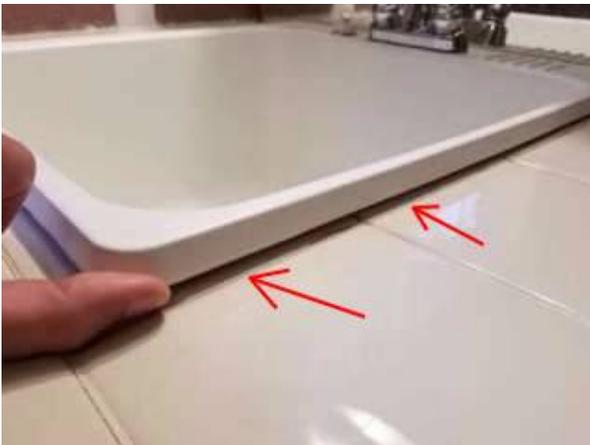
Photo 28-1

Gaps, no caulk, or substandard caulking were found between countertops and backsplashes and/or around the sink at location (s) #C. Water can penetrate these areas and cause damage. Recommend that a qualified person repair as necessary. For example, by installing or replacing caulk.

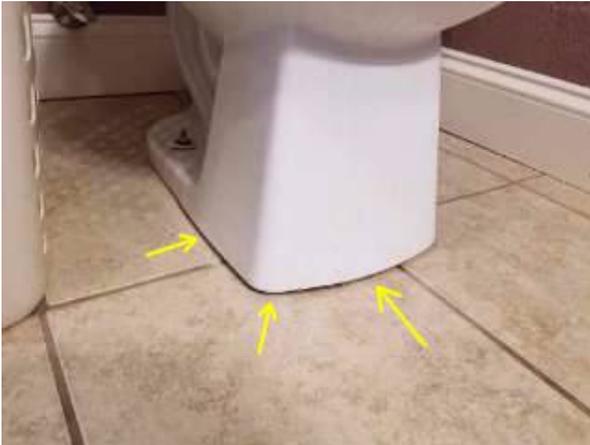
Photo 29-1

Caulk around the base of the toilet at location(s) #C was missing, substandard and/or deteriorated. Modern standards require caulk to be installed around the entire toilet base where it meets the floor for sanitary reasons. Without it, soiled water can soak into flooring and sub-floor materials if the toilet overflows. Condensation from the toilet can also soak into the flooring. Recommend that a qualified person caulk around toilet bases per standard building practices.

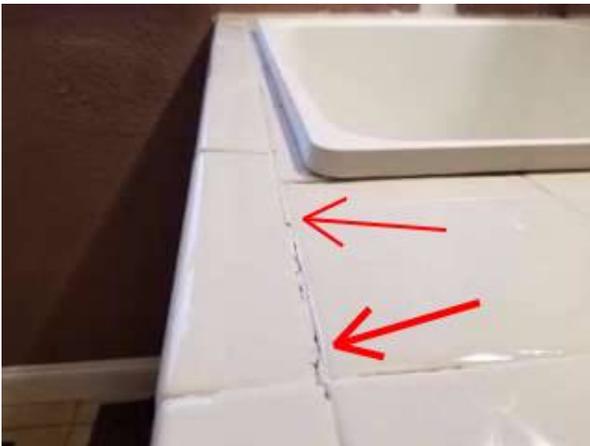
Photo 30-1

Recommend cleaning and sealing the grout at countertops at location(s) #C now and in the future as necessary to prevent staining and to improve waterproofing.

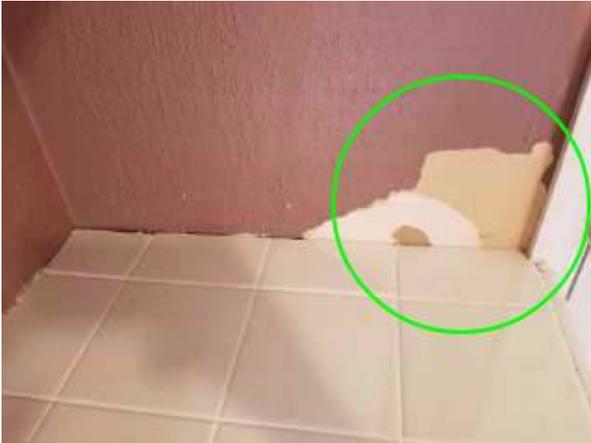
Photo 31-1

31) Drywall needs attention in Laundry room. Mostly cosmetic.

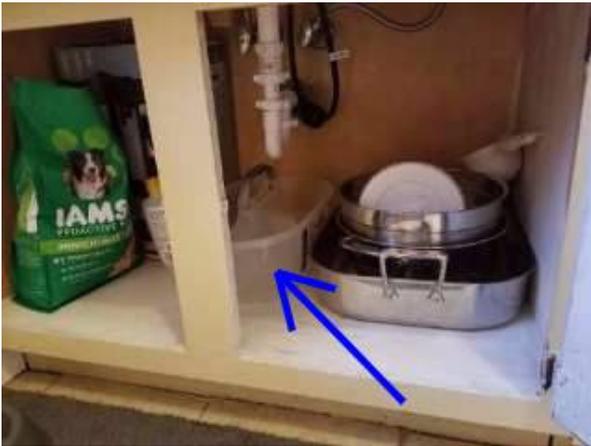
Photo 32-1

32) Laundry sink drain had a bucket under. Possibly leaked in the past. No sign of leaking during inspection. Probably want to keep an eye on it.

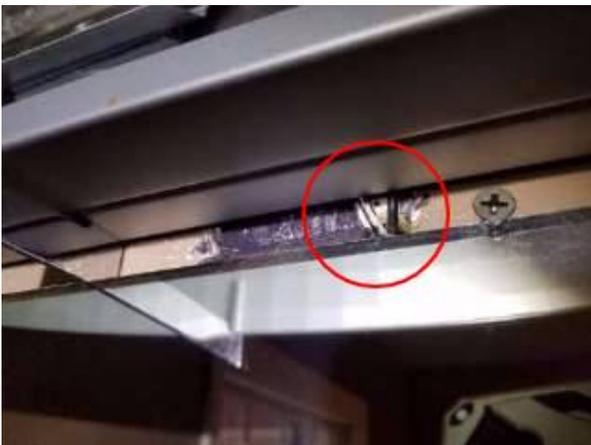
Photo 33-1

33) Laundry vanity light needs to be lowered to cover wires. Recommend qualified person do this.

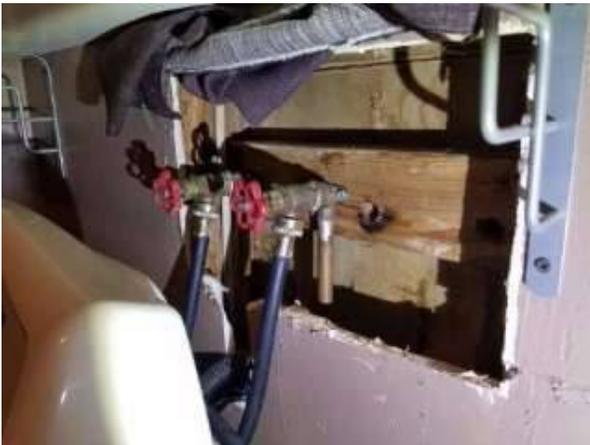
Photo 35-1

35) Washer hook-ups need attention. Sub-standard construction leaving a hole in the wall. Elec. wires exposed and signs of water damage on drywall. I am unaware of any code this breaks, but I would recommend it be repaired by a qualified person.

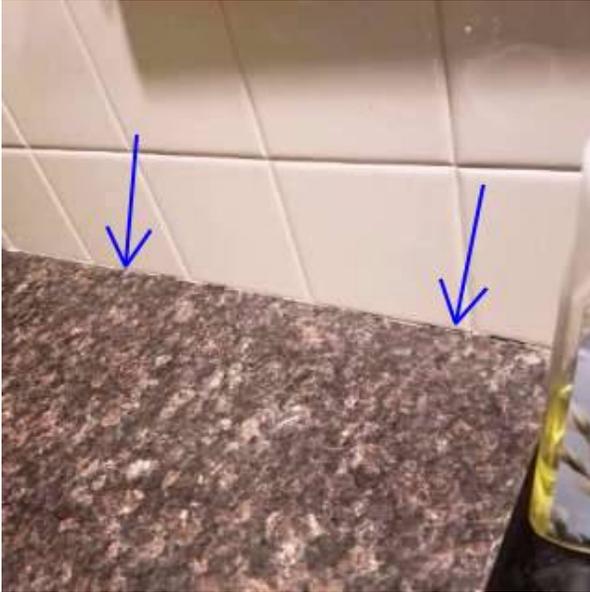
Photo 38-1

Gaps, no caulk, or substandard caulking were found between counter tops and back splashes. Water may penetrate these areas and cause damage. Recommend that a qualified person repair as necessary. For example, by installing caulk.

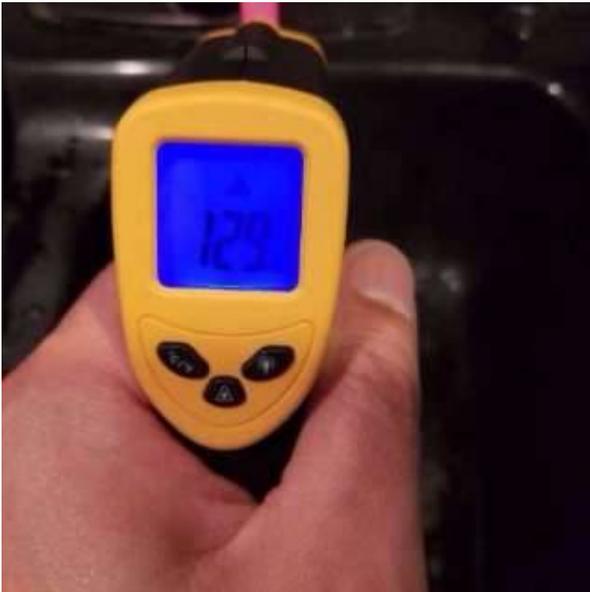
Photo 39-1

Water measured at 129 degrees Fahrenheit. The Department of Energy recommends having your tank-based hot water heater set to 120 degrees Fahrenheit for most homes. Prevents burns on children and saves a little money.

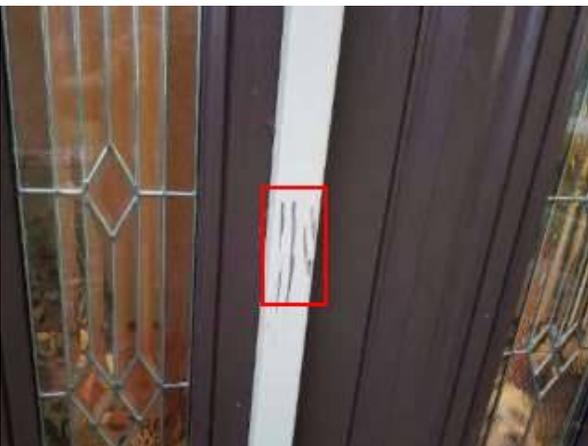
**Photo 42-1**

One or more exterior doors had minor damage and/or deterioration. Although serviceable, the client may wish to repair or replace such doors for appearances' sake.

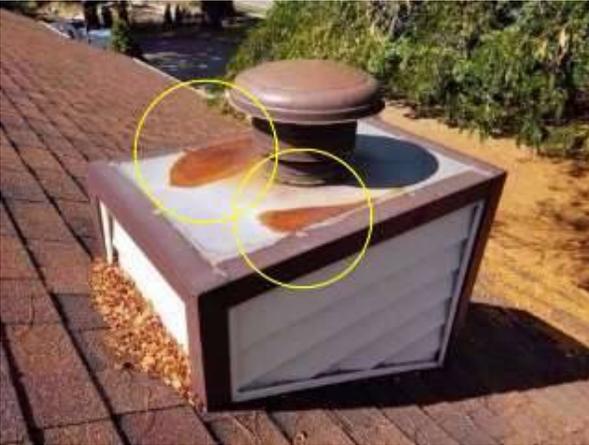
Photo 44-1

44) Chimney flashing appears to be in good shape. A couple rust spots on top - nothing too concerning. Would recommend painting to prevent further damage/corrosion.
